Site-Wide Preliminary Site Investigation (Contamination) Report

Ravensdown Napier Works

Prepared for Ravensdown Limited

Prepared by Beca Limited

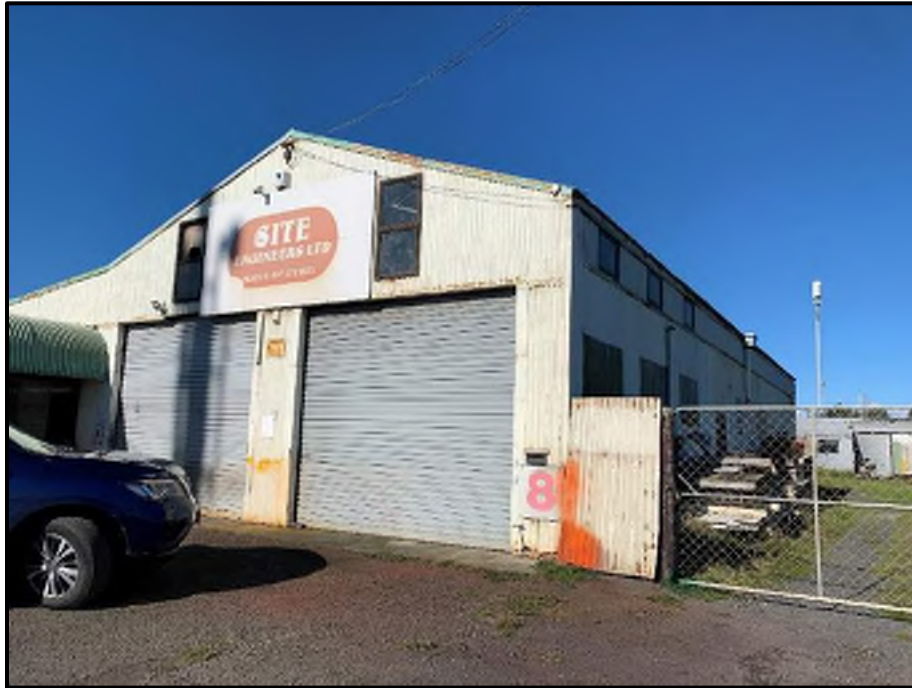
- A workshop (former truck shed and tannery) is located in the north-east of this area of the site. The workshop is currently operated by Pipe Co Engineering Ltd and utilised for small-scale fabrication, piping, maintenance, welding, repairs, machining etc. An associated old storage shed is located to the south of the workshop.
- No significant staining was noted on top of the concrete flooring within the workshop.
- The site representative reported that no waste oil is produced from the activities undertaken within this workshop.
- Electric cranes and a gas-powered forklift truck were noted in the workshop.
- A laboratory operated by Analytical Research Laboratories is located in the south of this area. An associated caged gas canister storage area was noted up against the south of the building.

Photograph 3: General View of the Current Engineering Workshop (Former Truck Shed and then Tannery) on Part Section 43 Block I Clive SD

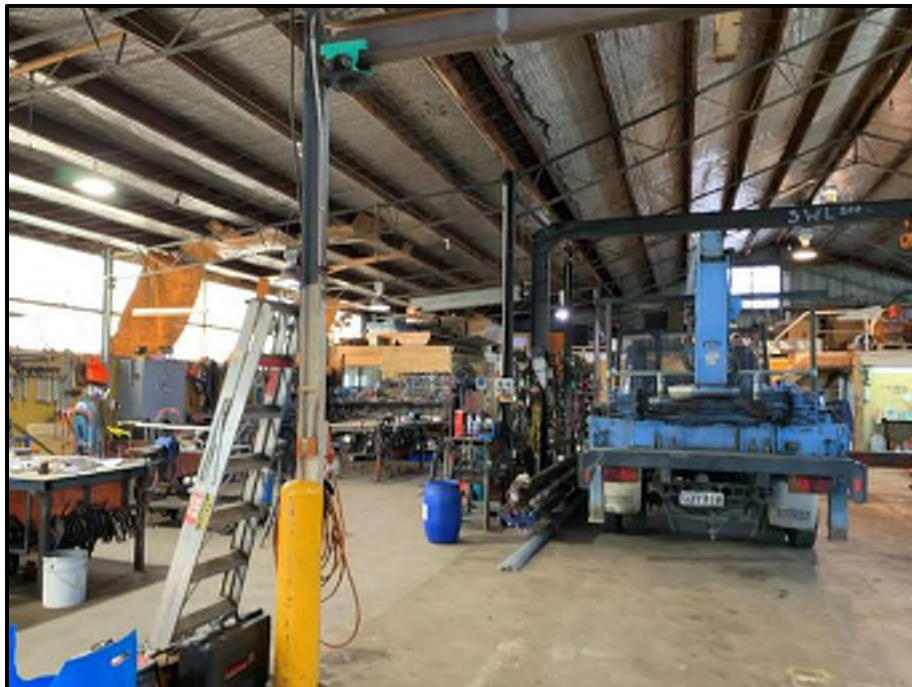
Photograph 4: Internal View of the Above Engineering Workshop

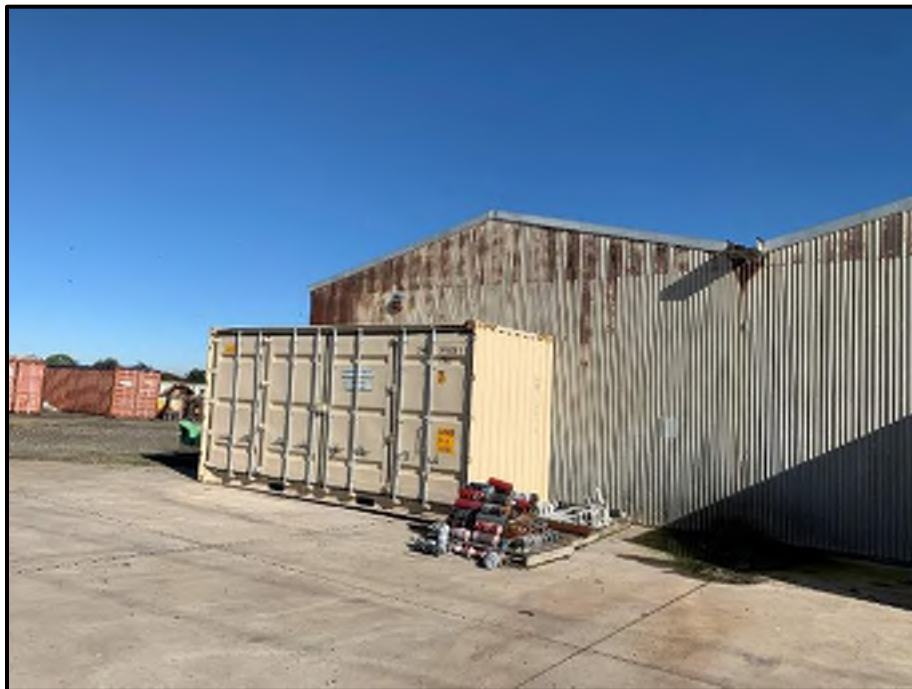
- An engineering store is located in the north of this land parcel. A number of locked containers ('inventory stores', including one for the storage of oils and grease) are located in the yard area surrounding the engineering store. No significant staining was noted on top of the concrete hardstanding within this area.
- The remainder of this land parcel predominantly supports grass covered land.

Photograph 10: Example View of the Shipping Containers used as Inventory Stores External to the Engineering Store on Lot 2 DP 16060

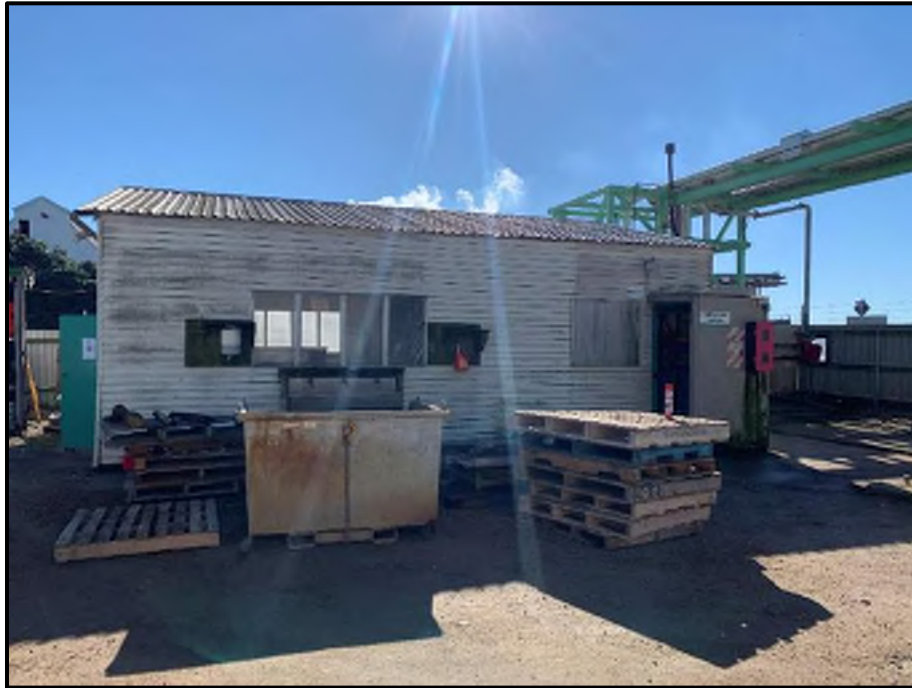
- A staff room ('Contractors Canteen', former laboratory) and a maintenance workshop are located within the north-west of this area. No significant staining was noted on top of the concrete flooring within the workshop.

Photograph 11: View of the Old Laboratory/Current Contractors Canteen on Part Section 32 Block I Clive SD

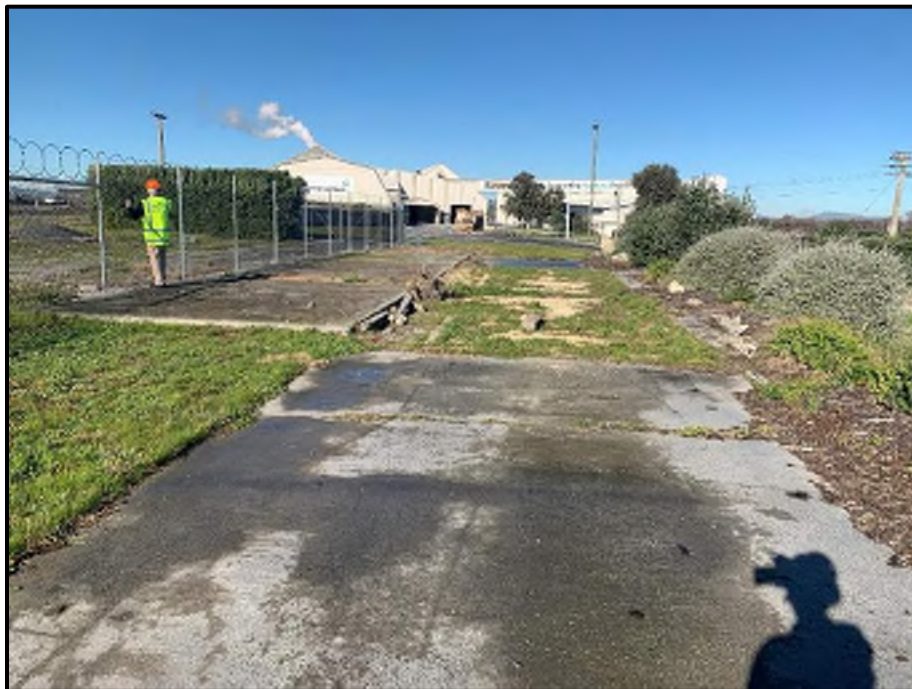
- A truck wash is located adjacent to the south of the workshop.
- Old concrete floor slabs are located south of the truck depot (assumed remnants of the former garage and weighbridge). Remnants of the old railway lines is also present in this area of the site (observed within a concrete access road in a generally moderate to poor condition).

Photograph 20: Remnants of the Former Weighbridge South of the Truck Depot

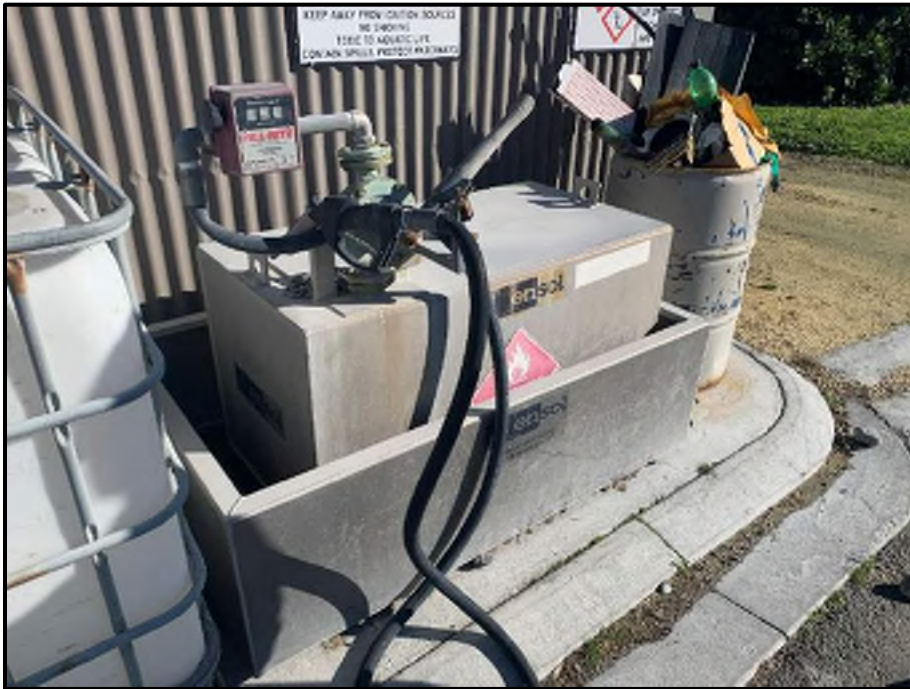
- A small c.500 litre steel petrol AST is located within a steel bund external to a small gardeners maintenance shed in the north of the site (utilised for refuelling gardening and general maintenance equipment). The associated fill point and dispense point were noted to be located within the banded area. No significant staining was noted on the concrete and asphalt hardstanding within the vicinity of the tanks.

Photograph 22: View of the c.500 litre Petrol AST in the North of the Site

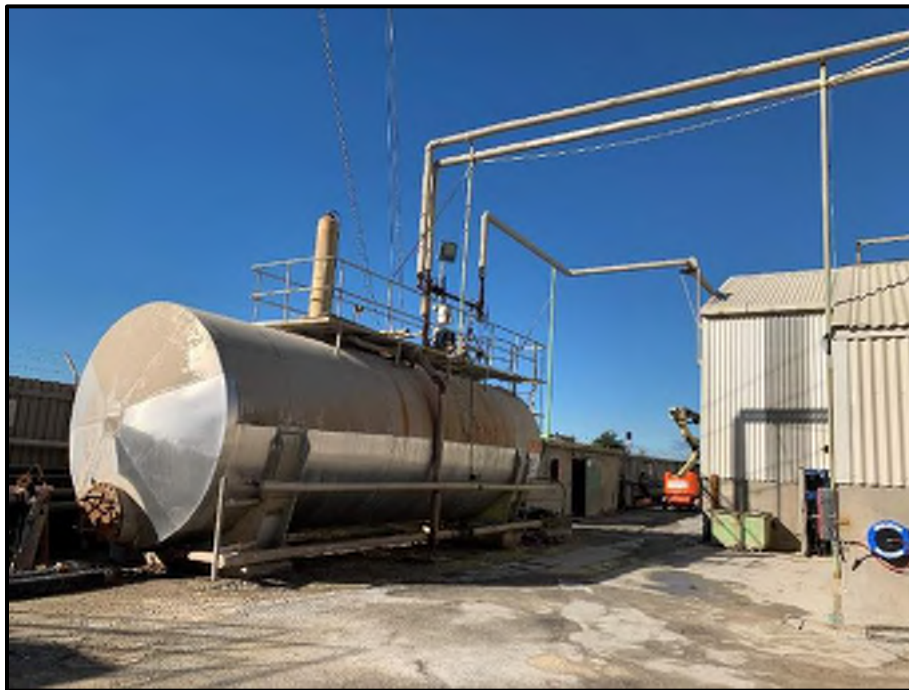
- A steel molten sulphur AST with associated aboveground pipework is located external to the south-east of the Manufacturing and Granulation building. A disused former hazchem store is located within this vicinity. No significant staining was noted on top of the concrete flooring within the store.

Photograph 26: View of the Molten Sulphur AST South-East of the Manufacturing and Granulation Building

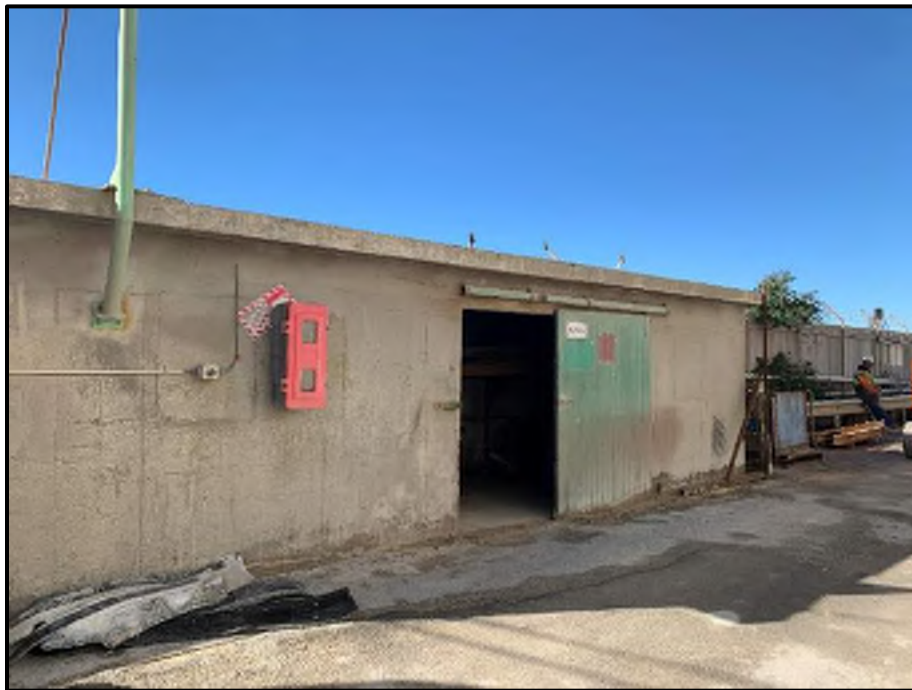
Photograph 28: View of the Disused Former HazChem Store South-East of the Manufacturing and Granulation Building

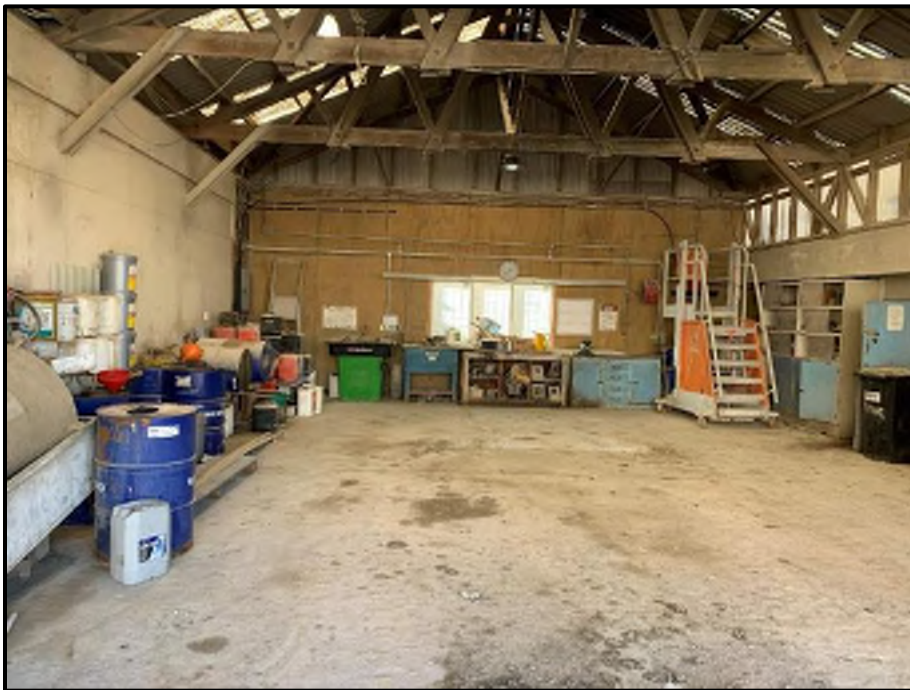
- A maintenance workshop and garage (reportedly utilised for general repairs and welding) are located south of the Manufacturing and Granulation building. No significant staining was noted on top of the concrete flooring within these structures.

Photograph 30: Internal View of the Garage South of the Above Workshops

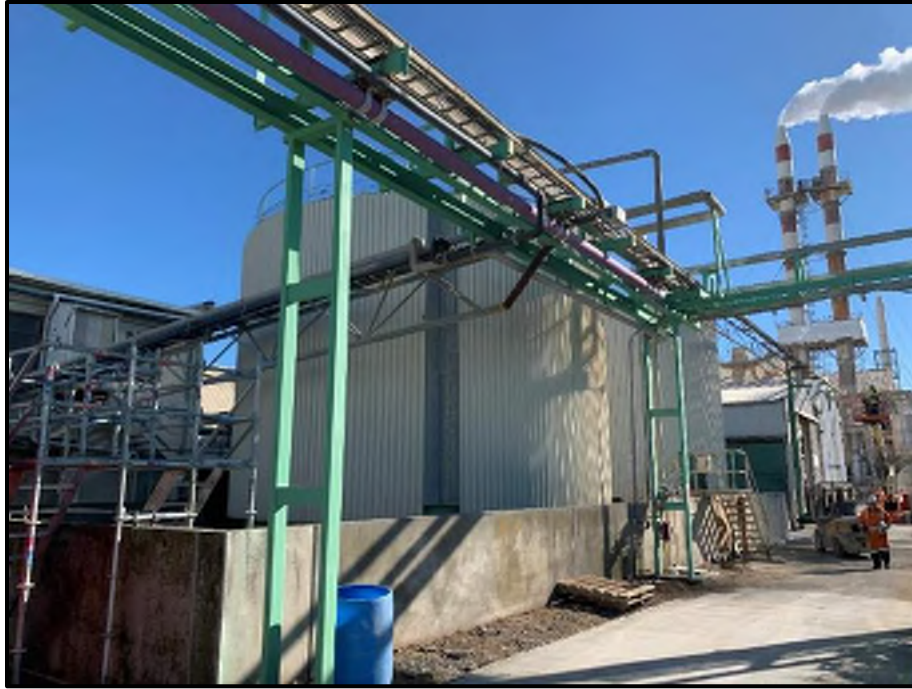
- Two large acid ASTs are located within a concrete bund externally adjacent to the south of the garage. No significant cracks etc were noted in the concrete bund.

Photograph 31: View of the Bunded Acid Tanks South-East of the Above Garage

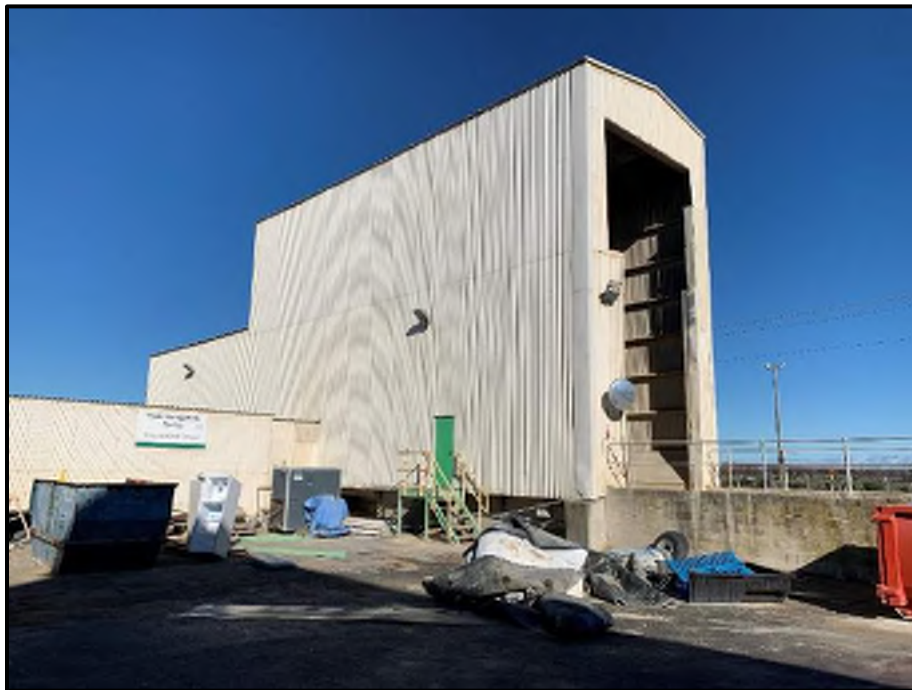
- From 1984, various applications were submitted for a license to store dangerous goods (including two Underground Storage Tanks - UST), locations were not provided). Site staff were not aware of any current or historical USTs. However, an unconfirmed recollection of a possible UST was noted adjacent to the east of the Intake area.

Photograph 32: View of the Intake Area Towards the South of the Site

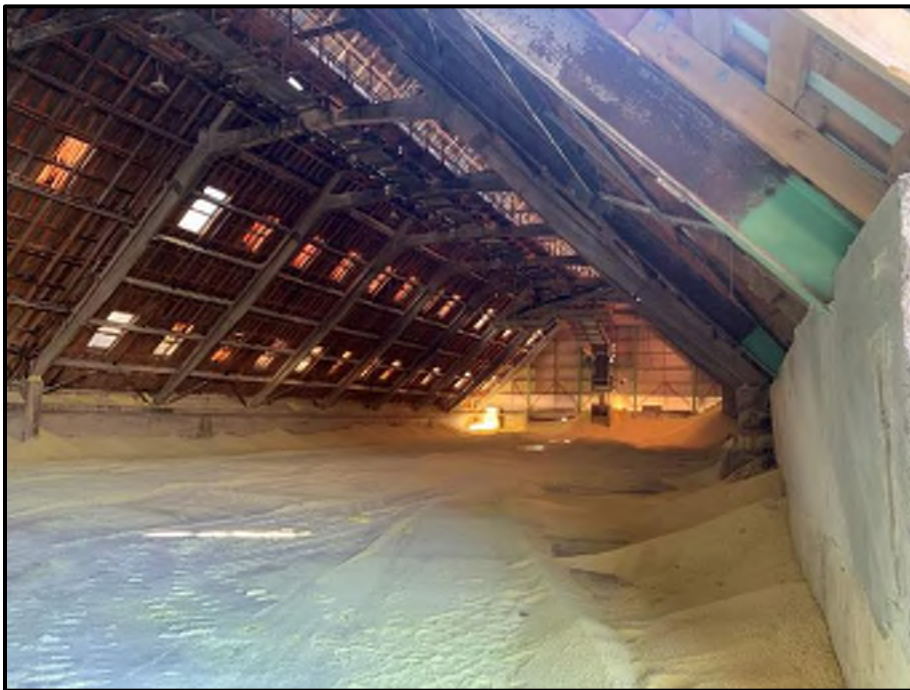
- Infrastructure referred to as 'Intake' is located south of No 1 Rock Store.
- Two large sulphur stores are located south of the acid tanks. Suspected asbestos containing materials was noted in the roofing of the older sulphur store. Moss was noted to be growing on the cement roof sheeting.

Photograph 34: Internal View within the Older Sulphur Store Towards the South of the Site

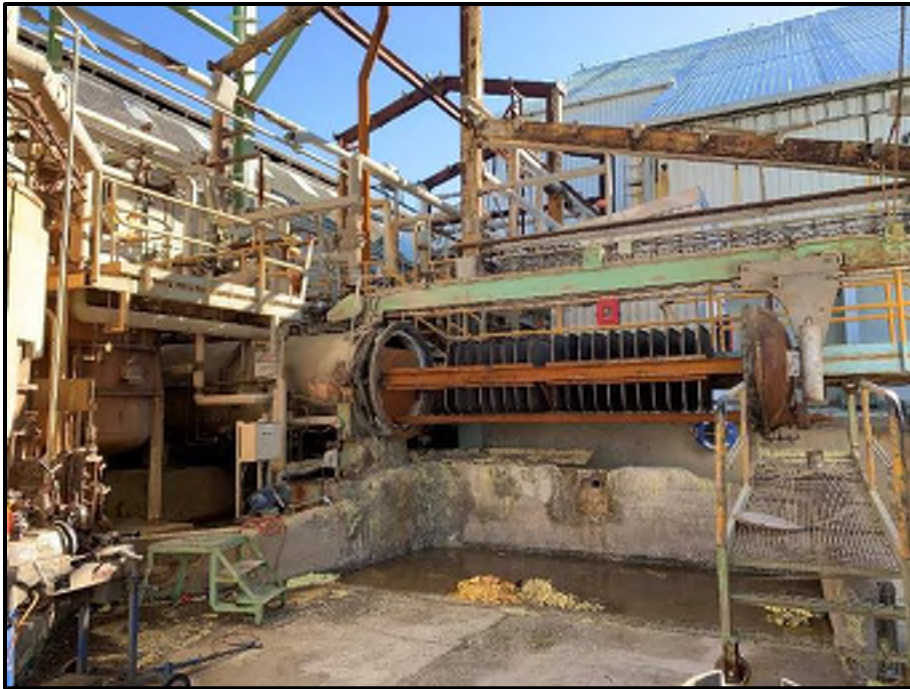
- A 'Sulphur Melter' is located adjacent to the south-east of the sulphur stores. Sulphur staining was noted on top of the concrete hardstanding within this area of the site.

Photograph 36: View of the Sulphur Melter Towards the South of the Site

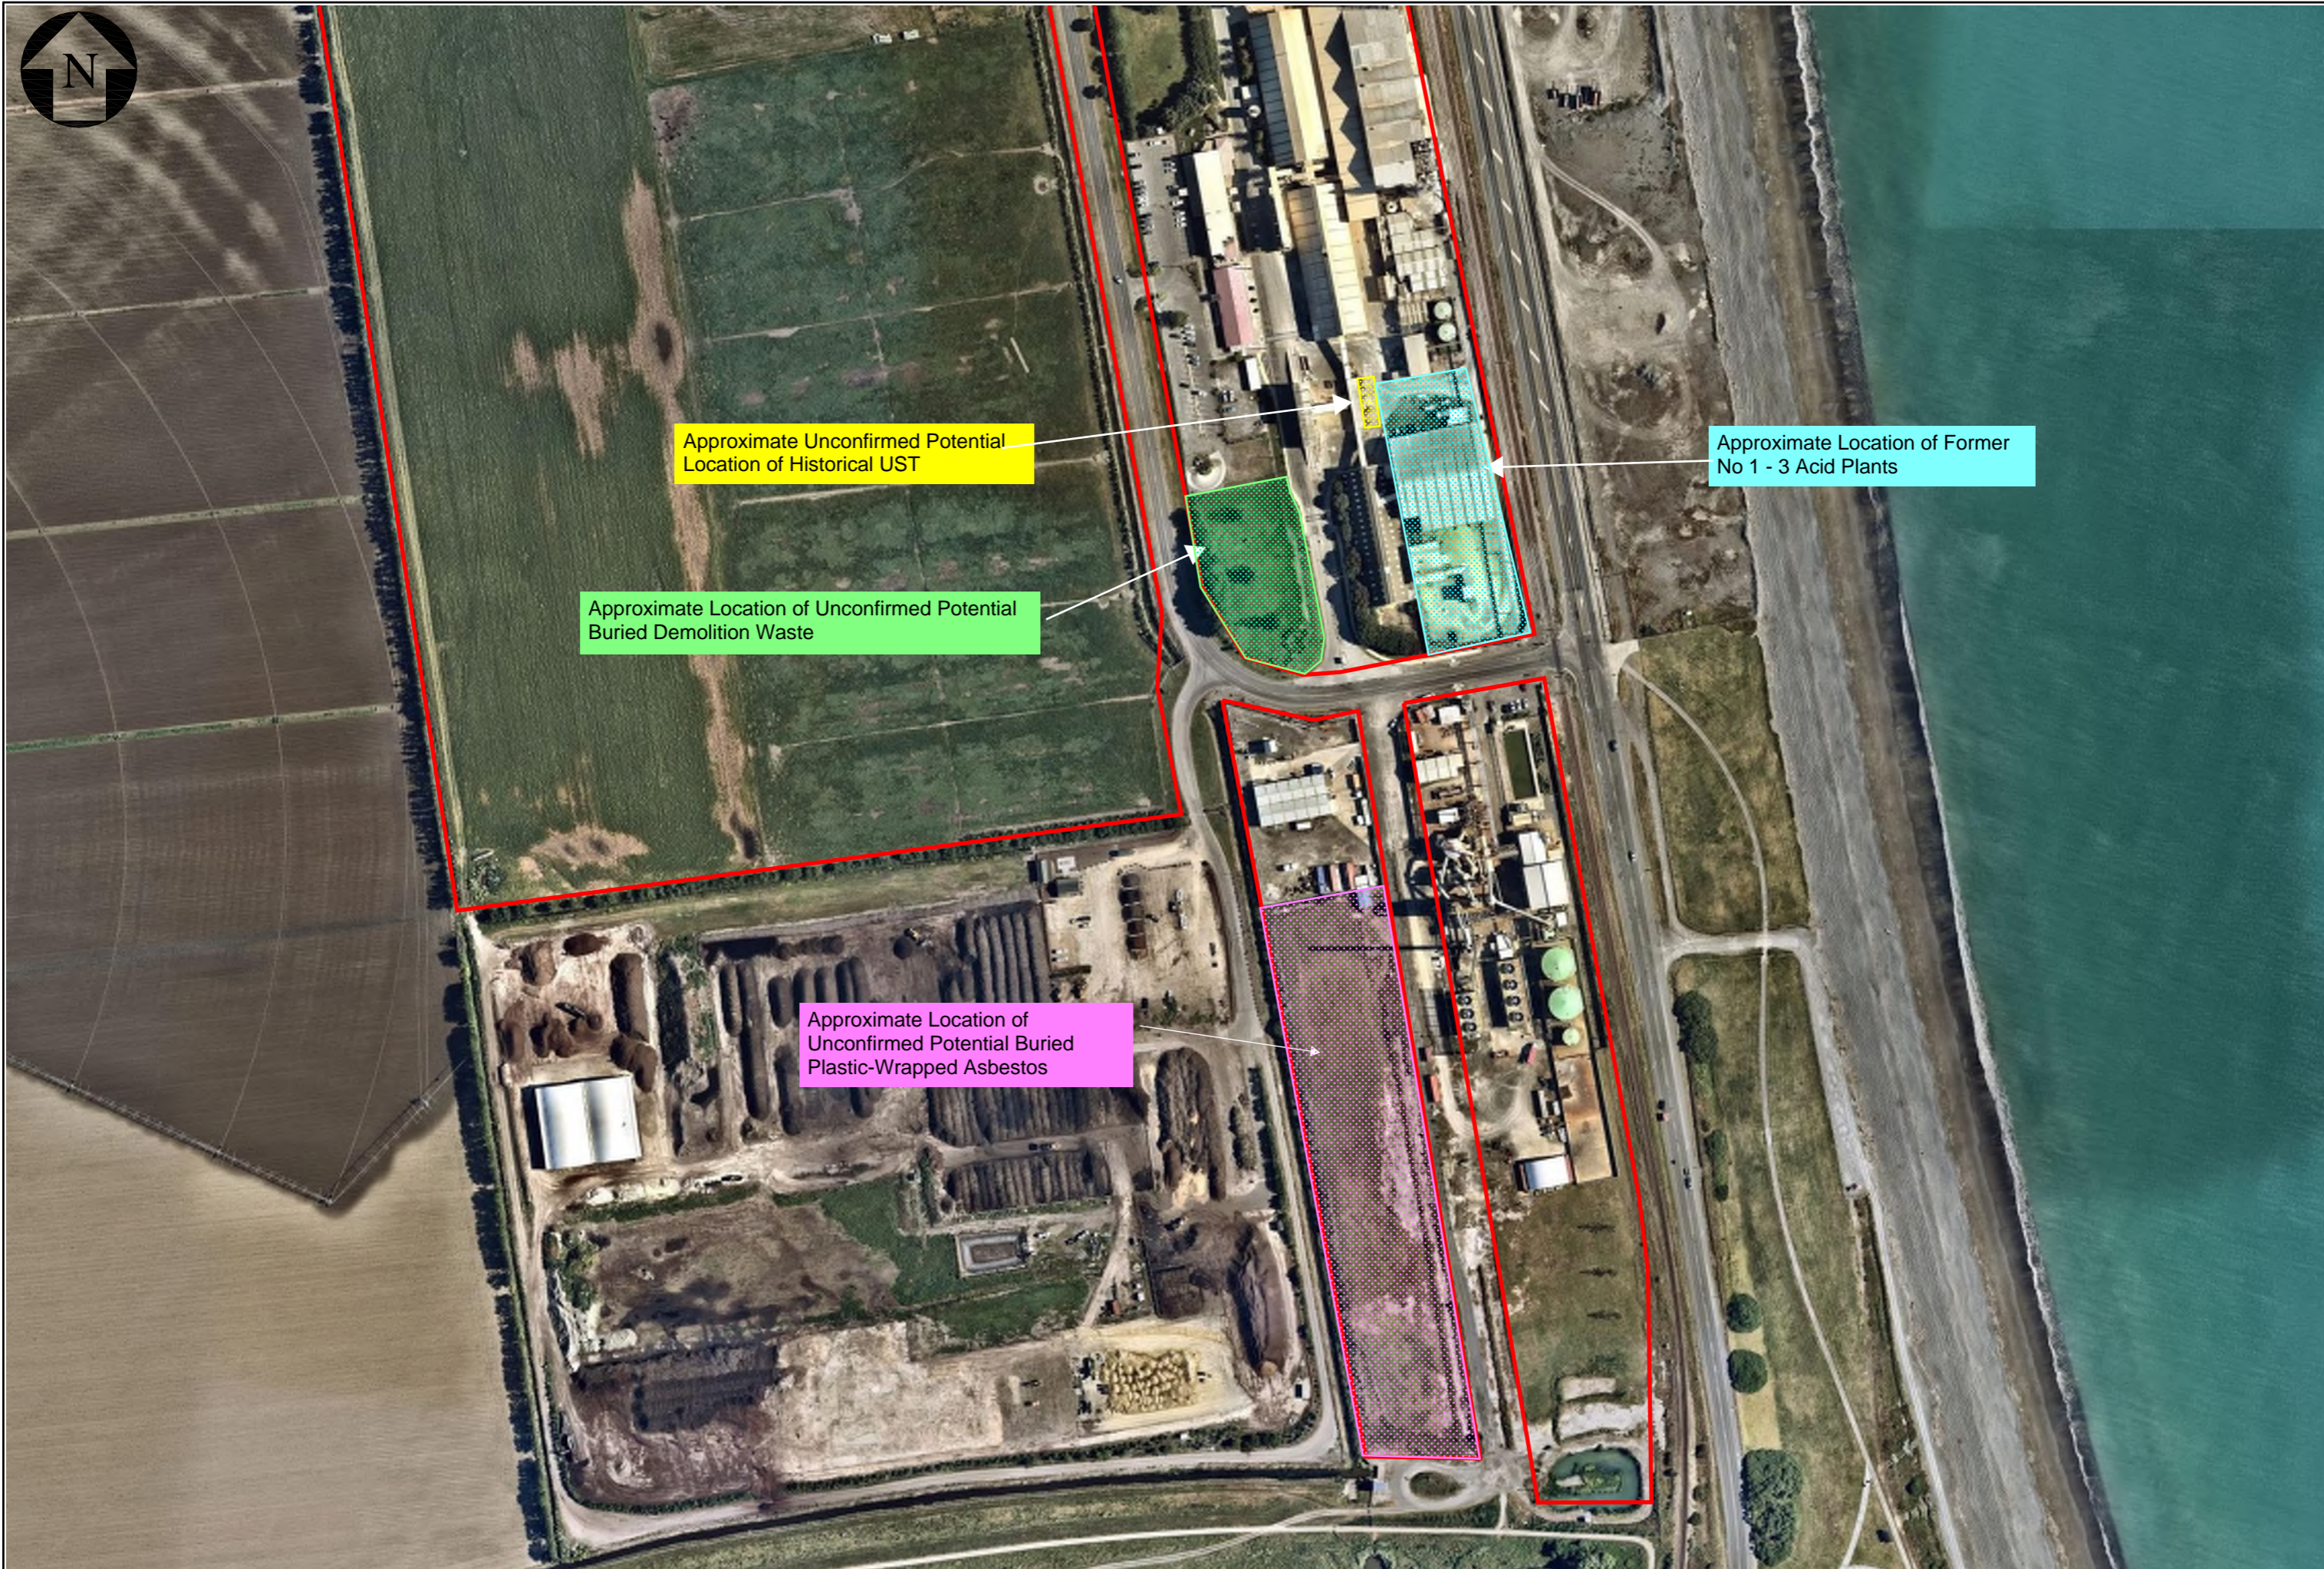
Approximate Unconfirmed Potential Location of Historical UST

Approximate Location of Unconfirmed Potential Buried Demolition Waste
