Site-Wide Preliminary Site Investigation (Contamination) Report

Ravensdown Napier Works

Prepared for Ravensdown Limited

Prepared by Beca Limited

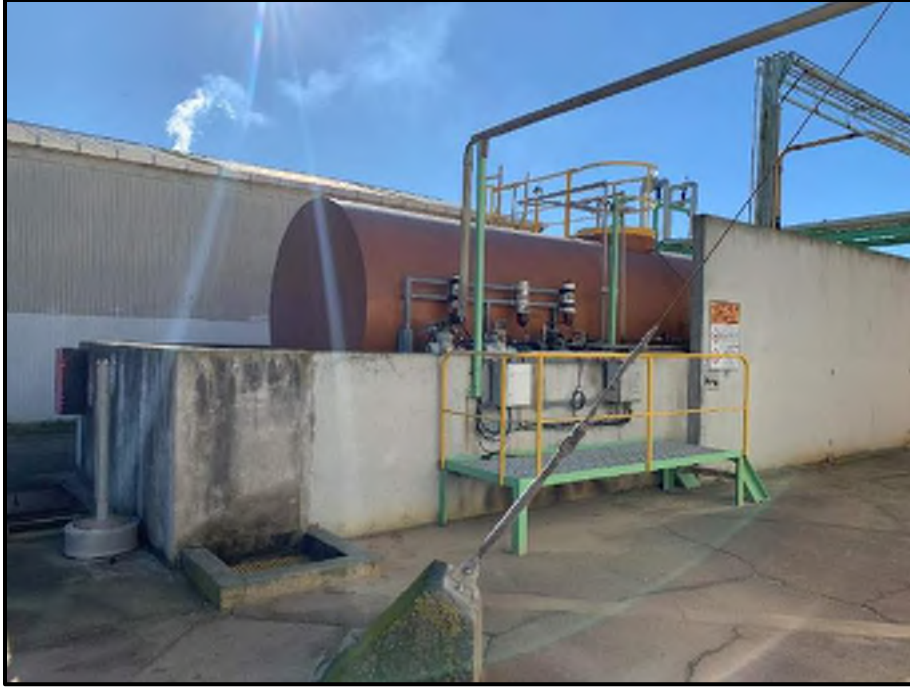
Photograph 13: General View of the Bunded Diesel Tank on Part Section 32 Block I Clive SD

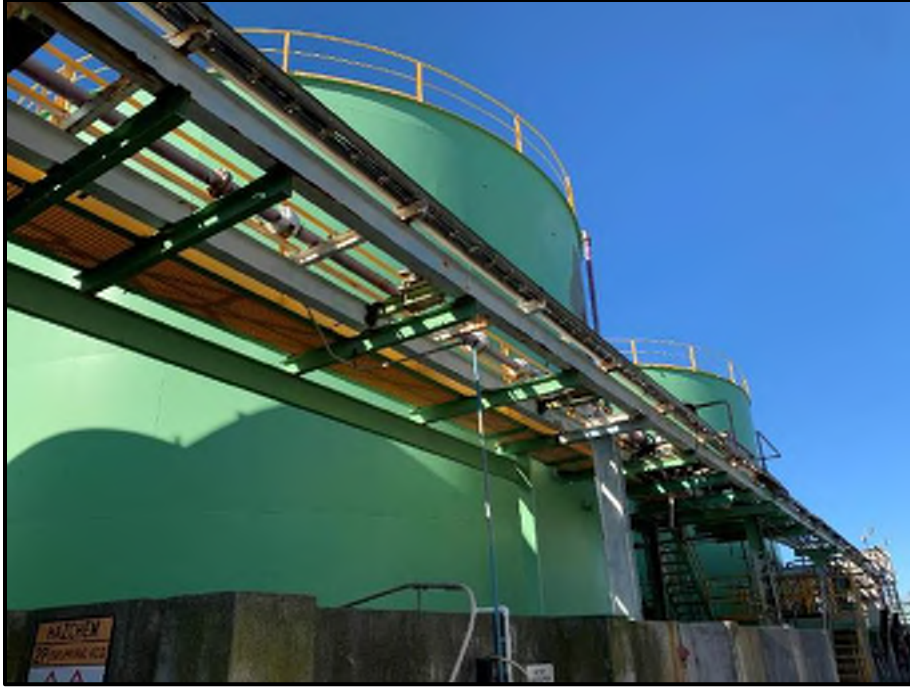
Photograph 15: General View of the Bunded Acid Tanks on Part Section 32 Block I Clive SD

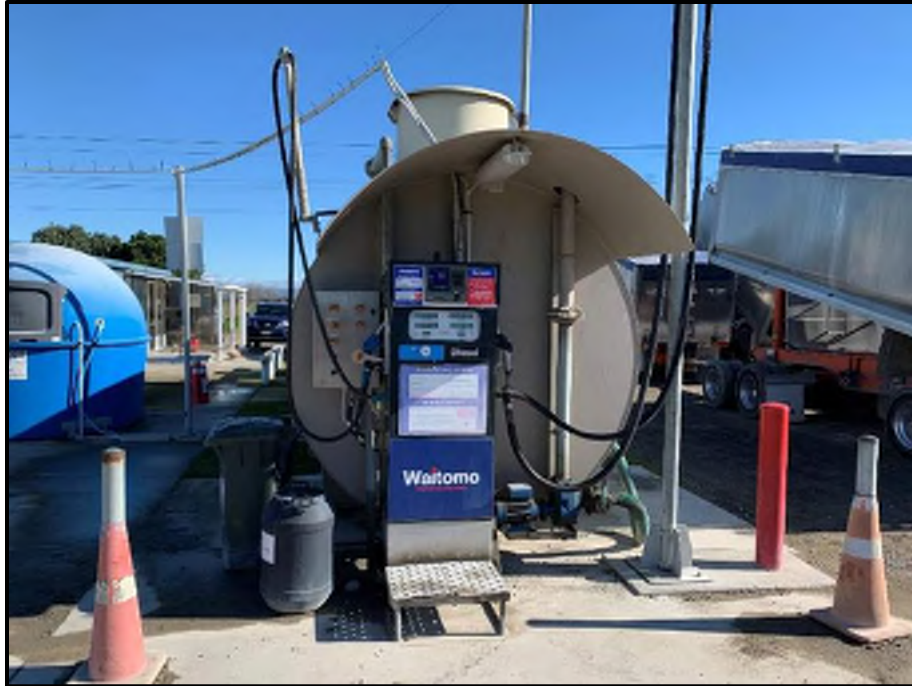
Photograph 19: View of the ASTs at the Truck Depot in the North of the Site

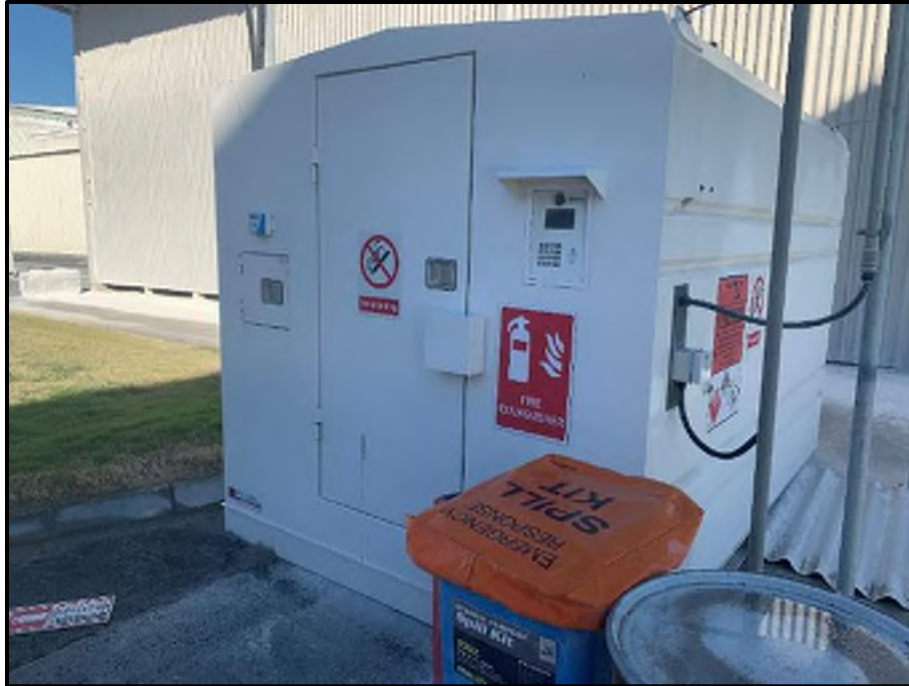
Photograph 25: View of the Diesel AST to the East of No 2 Despatch

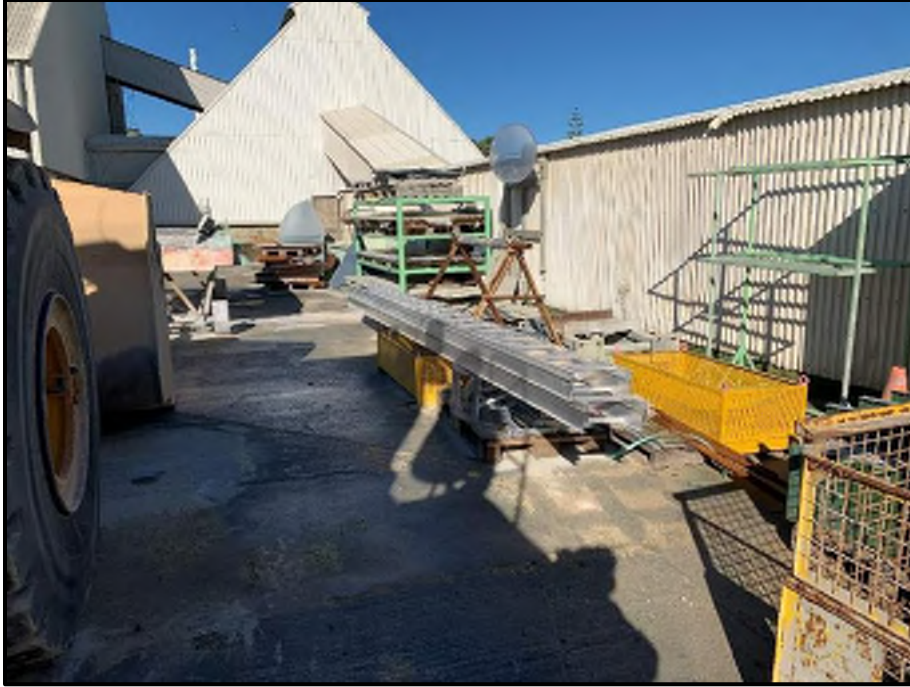
Photograph 33: View of the General Area Adjacent to Intake where Site Staff Recollected a Potential Former UST

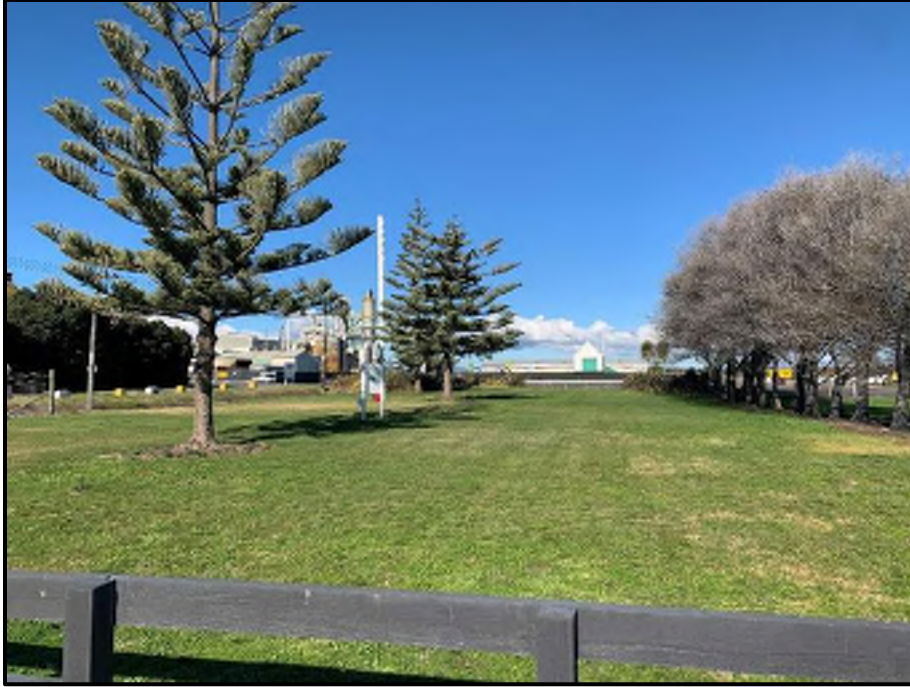
Photograph 35: View of The Grass-Cover Area West of the Sulphur Store Above (where anecdotal information suggests the potential presence of buried acid plant demolition waste)
